Dislocation of a polished femoral stem following a cemented total hip arthroplasty: A report of 2 cases

We report 2 cases of hip dislocation after a total hip arthroplasty, which could not be successfully reduced by closed method. Post-manipulation radiographs revealed proximal migration of the prosthesis in both cases, which required open reduction. The pathogenesis and treatment of this hip dislocation is discussed.

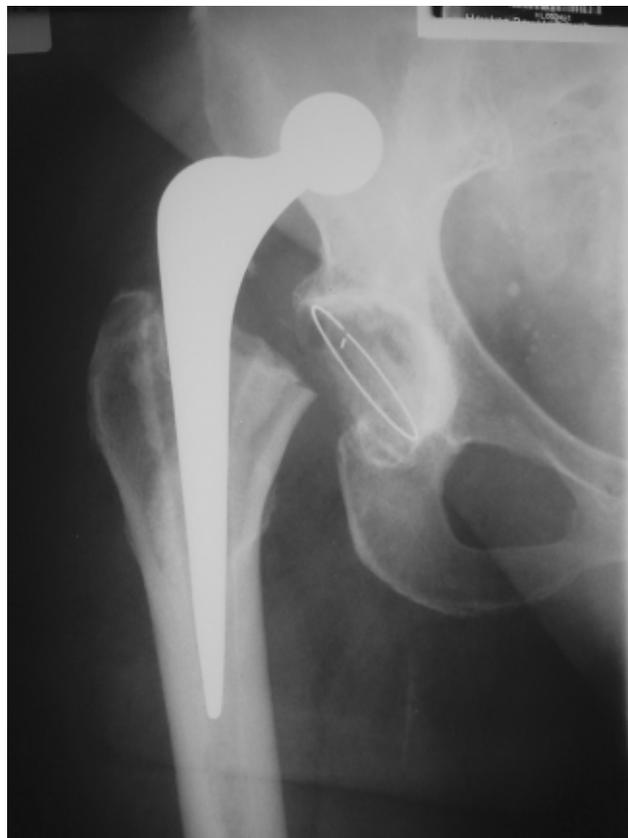
A month later, she slipped in the shower and posteriorly dislocated the prosthesis. The leg was shortened and internally rotated. An emergency registrar attempted to forcefully reduce the dislocation under midazolam and morphine, but the attempt was unsuccessful. Post-manipulation radiography showed a proximal dislodgement of the femoral prosthesis (Figure). The following day, an open reduction was performed through the previous surgical scar. The femoral component was reduced into the cement mantle and then the hip was reduced into the cup. A stable reduction was therefore obtained. At 12-month follow-up, the patient was able to walk without assistance. Radiographs showed no signs of loosening of the femoral component.

Figure Proximal dislocation of the polished stem at the cement-stem interface.

When closed reduction of a dislocated polished femoral stem failed, open reduction should be performed by pushing the stem back to the cement mantle or using a one size smaller prosthesis in the cement mantle with cement over the shoulder. If instability persists, an extra-length head should be used.
