Case report: Pain L THR [post THR 2 years; with history of trivial fall]

Diagnosis: Ceramic head fracture

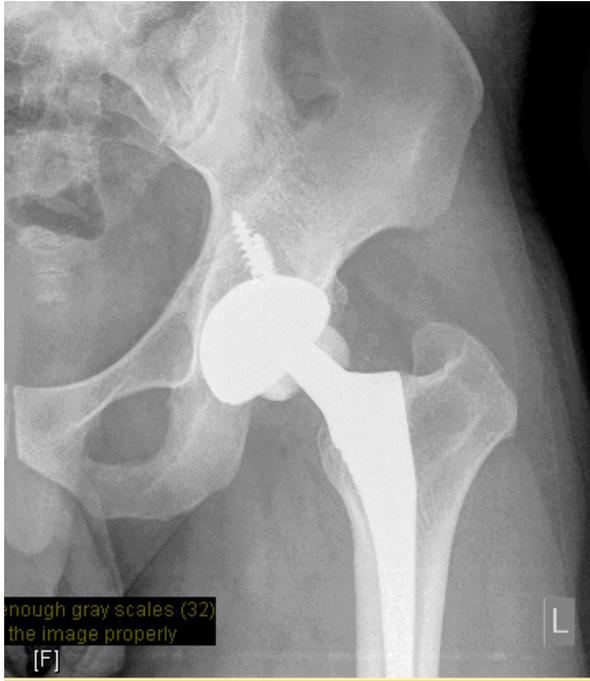
In this report, we present a 46-year old patient who underwent primary THA and was a victim of low-energy trauma [fall in the shower] four years later. Initial radiographs showed nonconcentric relation of the neck of the femoral stem to metal liner and the ceramic fragment appeared to have been overriding the superior part of the neck.

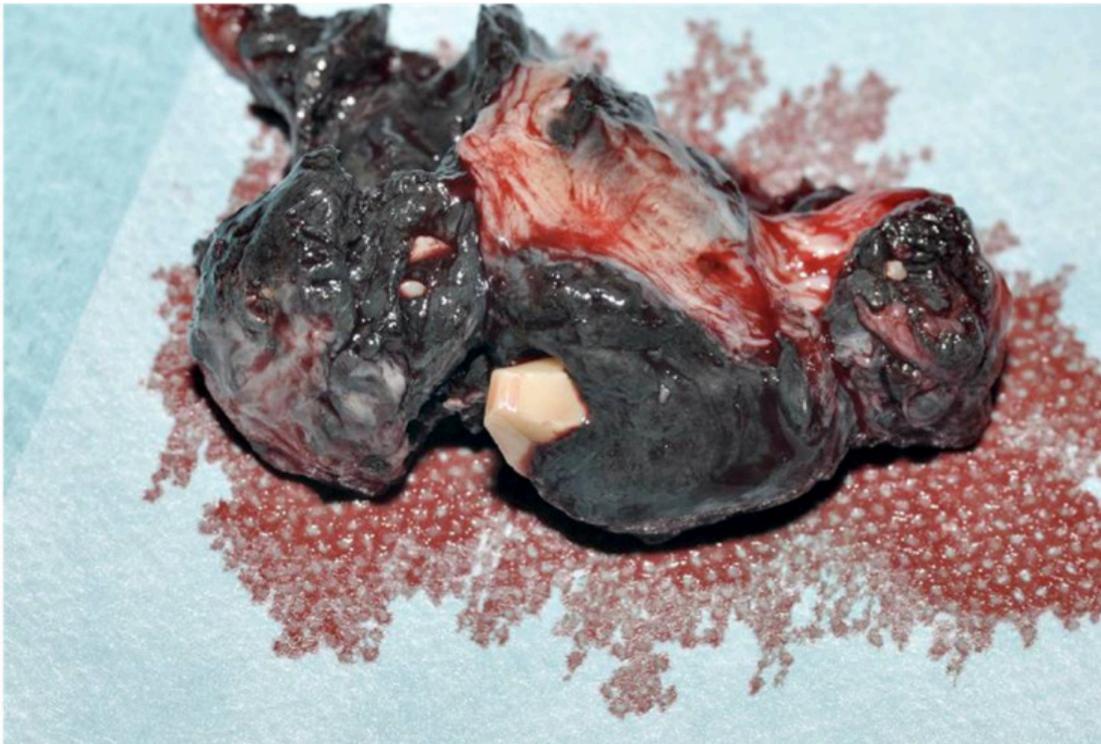
Operation

Posterior approach

Required extensive debridement of all synovial tissue

Extensive lavage

Convert to plastic on metal head; Or newer ceramic on ceramic
